TANK SYSTEMS REPORT US ECOLOGY NEVADA

March 2010

SECTION 10

TANK SYSTEMS REPORT

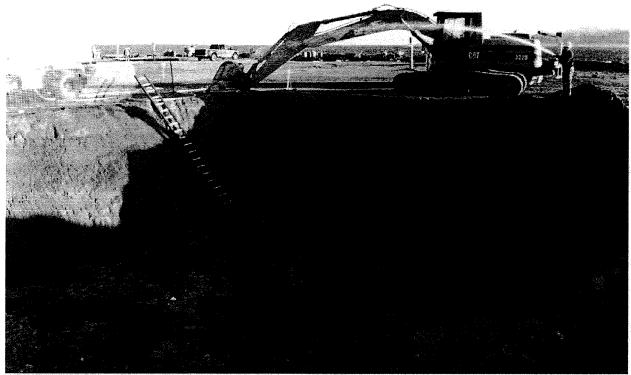
Photo — 1 The sand and gravel subgrade materials are moisture conditioned and compacted following excavation.

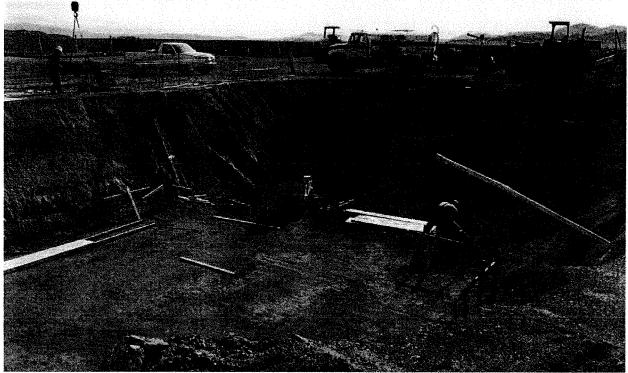
Photo – 2 Survey control for the foundation of mixing tank #1 is established while excavation continues for mixing tank #2.

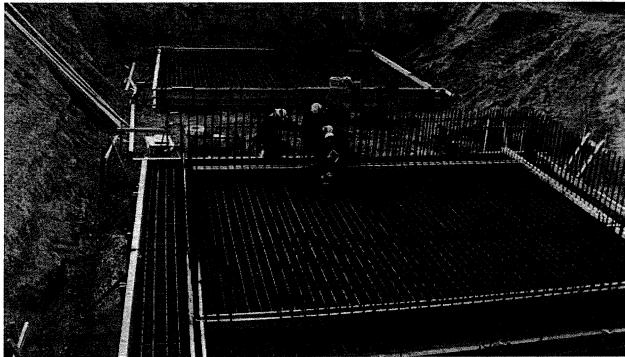
$\overline{Photo} = 3$ View of the #6 rebar installation prior to pouring the tank mat foundations.

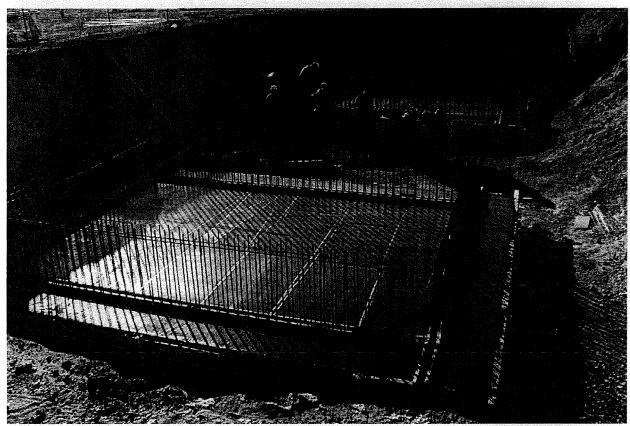
Photo -4 View of the freshly poured tank foundations.

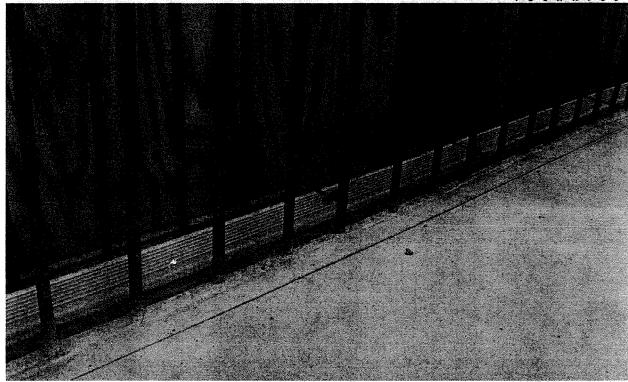
Photo - 5 View of a water stop installed along the construction joint located between the walls and the foundation of the tanks.

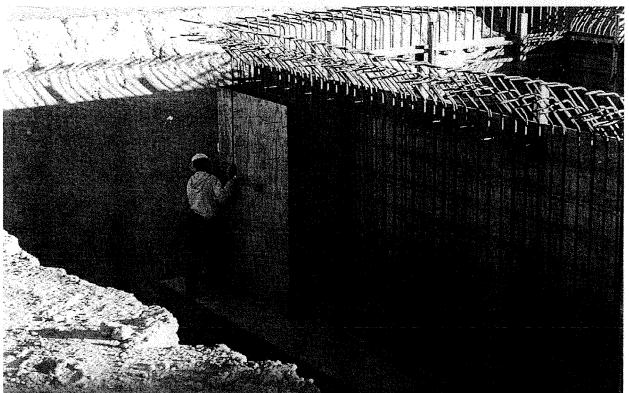
Photo -6 Typical view of the vertical and horizontal reinforcement in the walls of the tanks.

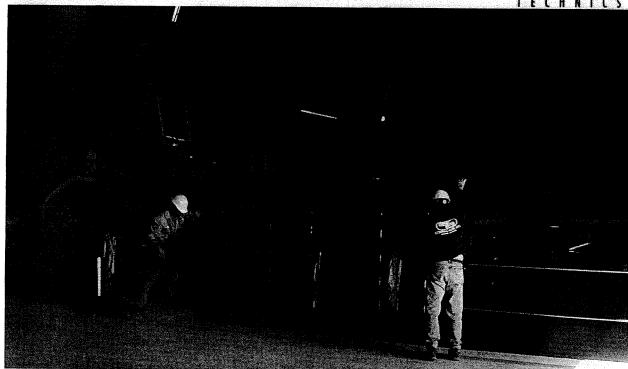
Photo-13 The steel vessels were constructed off-site in two halves and then transported to the site and lowered into position.

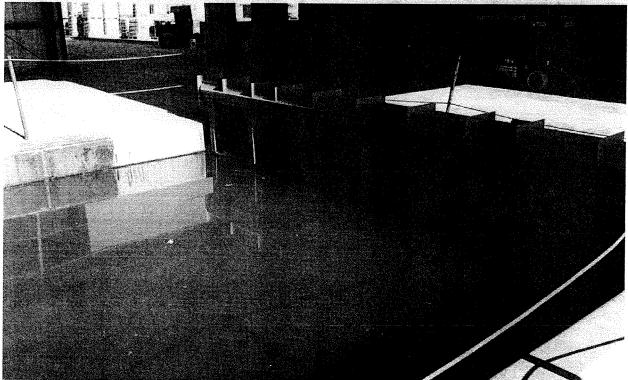
Photo-18 No leakage was observed into the secondary containment during the test period. A push jet manifold is visible on the far edge of the mixing tank.
